Contract #: 04-0120F4Cty: SF/ALA Rte: 80 PM: 13.2/13.9File #: 69.28**WELDING INSPECTION REPORT****Resident Engineer:** Pursell, Gary**Address:** 333 Burma Road**City:** Oakland, CA 94607**Report No:** WIR-001723**Date Inspected:** 07-Mar-2008**Project Name:** SAS Superstructure**OSM Arrival Time:** 1800**Prime Contractor:** American Bridge/Fluor Enterprises, a JV**OSM Departure Time:** 730**Contractor:** Zhenhua Port Machinery Company, Ltd (ZPMC), Changxing Island **Location:** Shanghai China**CWI Name:** Sha Zhi**CWI Present:** Yes No**Inspected CWI report:** Yes No N/A**Rod Oven in Use:** Yes No N/A**Electrode to specification:** Yes No N/A**Weld Procedures Followed:** Yes No N/A**Qualified Welders:** Yes No N/A**Verified Joint Fit-up:** Yes No N/A**Approved Drawings:** Yes No N/A**Approved WPS:** Yes No N/A**Delayed / Cancelled:** Yes No N/A**Bridge No:** 34-0006**Component:** Tower 89m Mock-up**Summary of Items Observed:**

WELDING INSPECTION REPORT

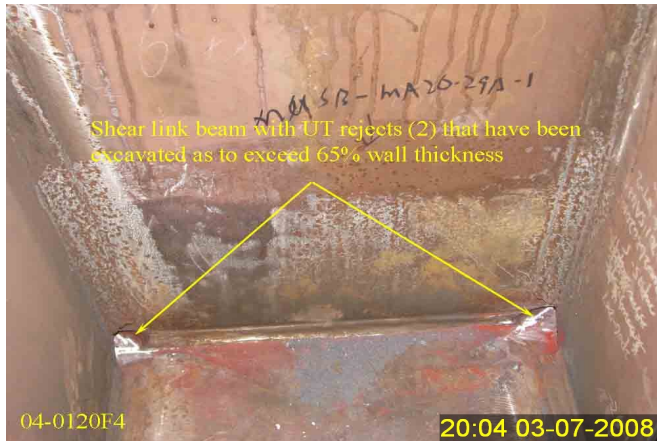
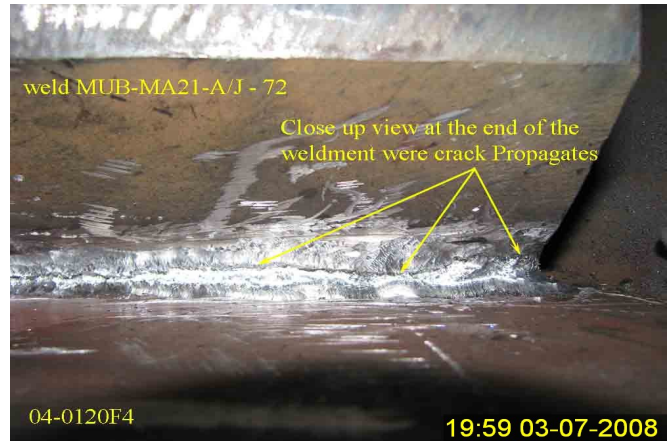
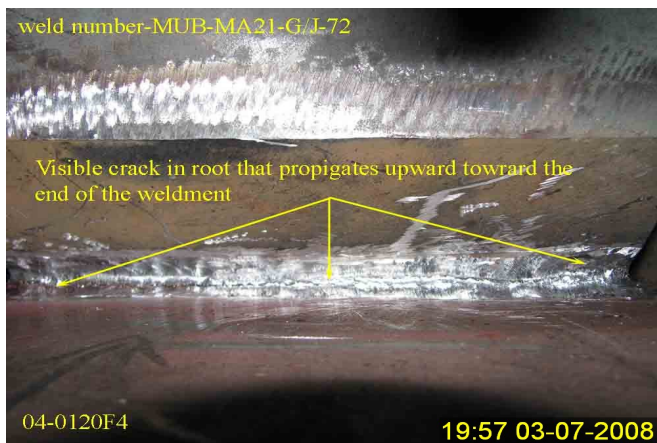
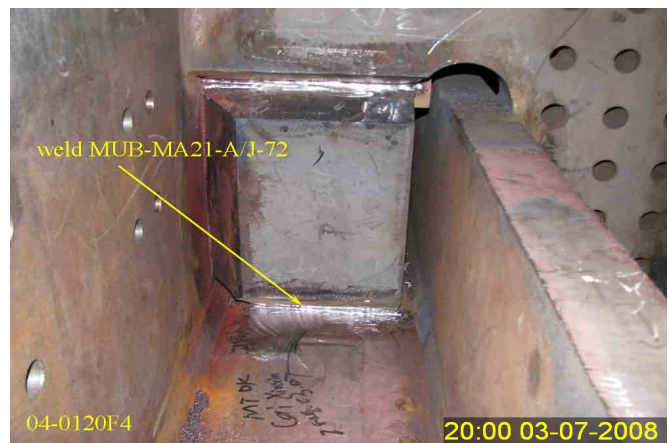
This Quality Assurance (QA) inspector upon arrival at ZPMC for observation of the 89m mock up observed and witnessed ZPMC personnel performing Magnetic Particle (MT) inspection for the root pass on a Partial Penetration (PJP) Groove weld number MUB-MA21-G/J 72 by MT Technician Cai Xin Xin. It was relayed to this QA inspector that the root pass was acceptable with no rejectable indications noted. While performing the observation it was noted that ZPMC performed 2 excavations for Ultrasonic Testing (UT) rejectable indications on shear link beam MA26-1 weld number MUSB-MA26-29A-1 were beyond 65% thickness of the material see digital photo below. This QA inspector spoke with ZPMC QC inspector Shen Xue Jun and Certified Welding Inspector (CWI) Sha Zhi in regards to the depth. Also noted was A PJP weldment number MUB-MA21-A/J-72 which had a visible crack for the complete length of the weld. ZPMC had relayed that they believed it to be the root gap creating the indication line but upon further review it was noted that the line did not stay parallel to the groove but traveled in an upward fashion see digital photo below. It was relayed to this QA inspector that the QC and CWI inspector would relay the information to their production department for further review of both areas of concern and for direction of how to proceed.
